NTE1045 Integrated Circuit FM/TV Sound IF Amp, Detector

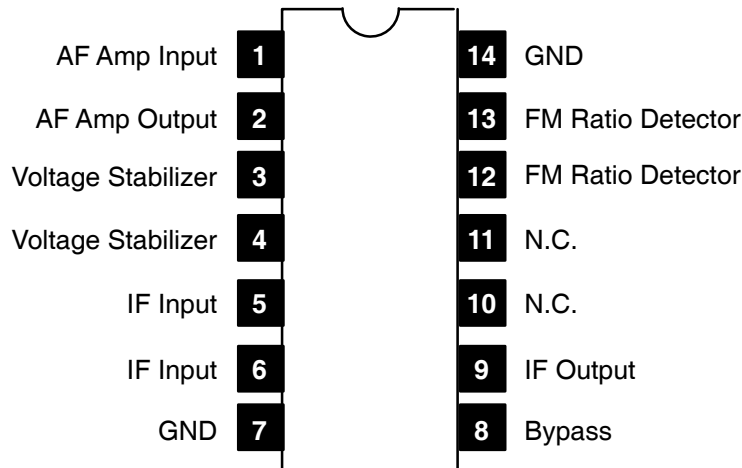
Pin Connection Diagram
(Front View)
